QE90 KEYPAD CONNECTOR FAULTS

IDENTIFICATION & FIELD CHANGEOVER PROCEDURE

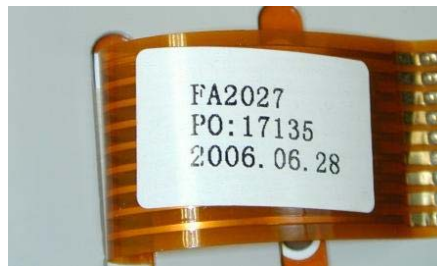
Fig 1 – Typical Batch Label (this one dated 28th June 2006)

If the batch label date is in the range 1st March 2006 (2006. 03. 01) to 30th October 2006 (2006. 10. 30), then the keypad is potentially affected, however the actual failure incidence appears to be small and also appears to drop off rapidly with time (i.e. most failures have been detected in factory test or during system commissioning).

Based on to-date failures and warranty return rates, keypad replacement whenever a fault is observed is the recommended action.

Nevertheless, Tyco Safety Products recommends increased vigilance during routine testing and service of QE90 EWIS systems installed in late 2006 and early 2007, particularly in regards to checking correct operation of keypad buttons. Where symptoms as described above are experienced, all keypads (ECP and extender) at the affected MECP or SECP should be replaced.
