MX1-NZ Replacement Door (FP0990)

Installation Instructions

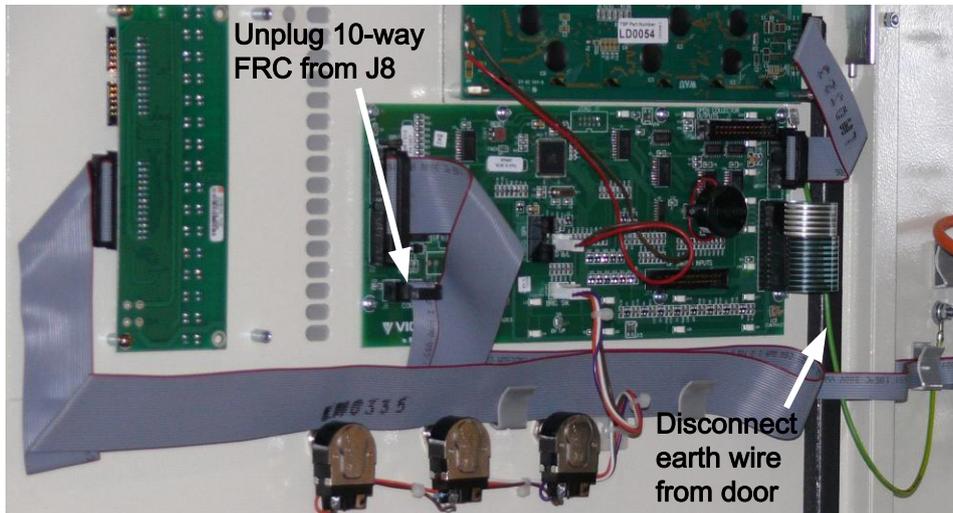
Figure 1 – Connections to a Front Service Door

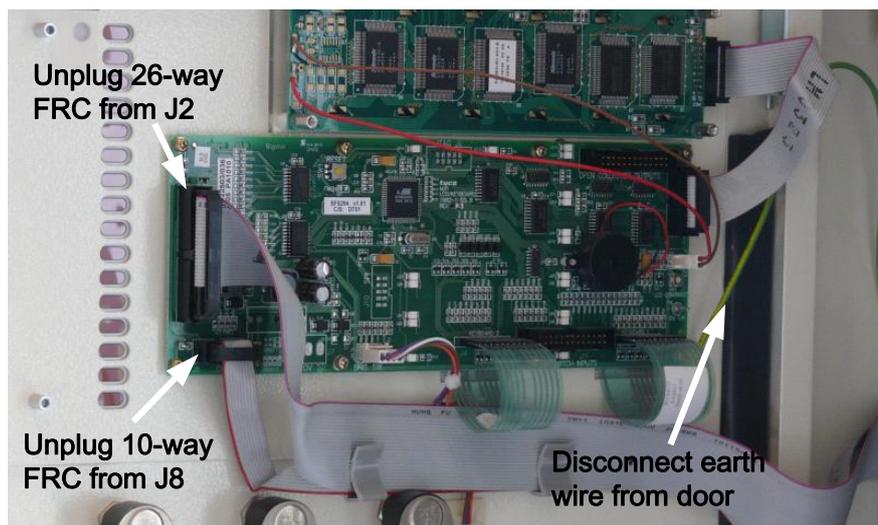
Figure 2 – Connections to a Rear Service Door

3. Use appropriate anti-static precautions when handling the internal parts of the system, e.g., earthing wrist strap connected to the case earth.
4. Disconnect the wiring from the cabinet body to the door.
For a front service cabinet, remove both the 10-way FRC from J8 of the PCB and the earth wire as in Figure 1. Unless the 10-way loom is damaged, there is no reason to replace it. If it is not required, unclip the 10-way FRC from the new door and discard it.
For a rear service cabinet, also remove the 26-way FRC from J2 of the PCB as in Figure 2.

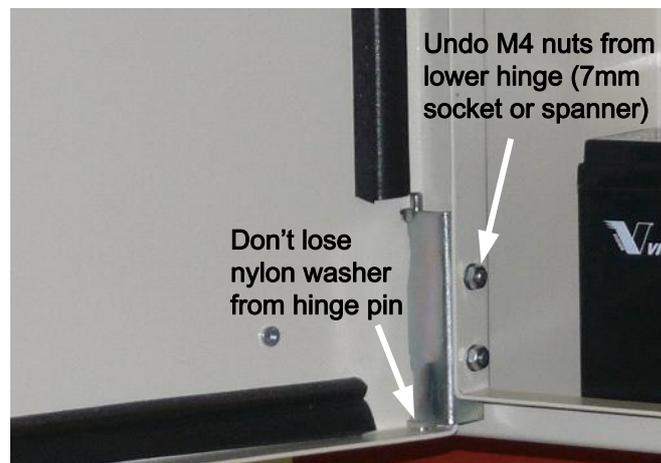
Figure 3 – Removing the hinge to release the door

5. Undo the nuts holding the lower door hinge as in Figure 3, and remove it, taking care not to lose the nylon washer on the lower pin.
6. Unhook the door from the upper hinge pin and lift it clear of the cabinet.
