# 4100ESi Upgrade Kits

## Installation Instructions

Existing 4100U and 4100ES systems can be upgraded to 4100ESi by fitting the appropriate upgrade parts.

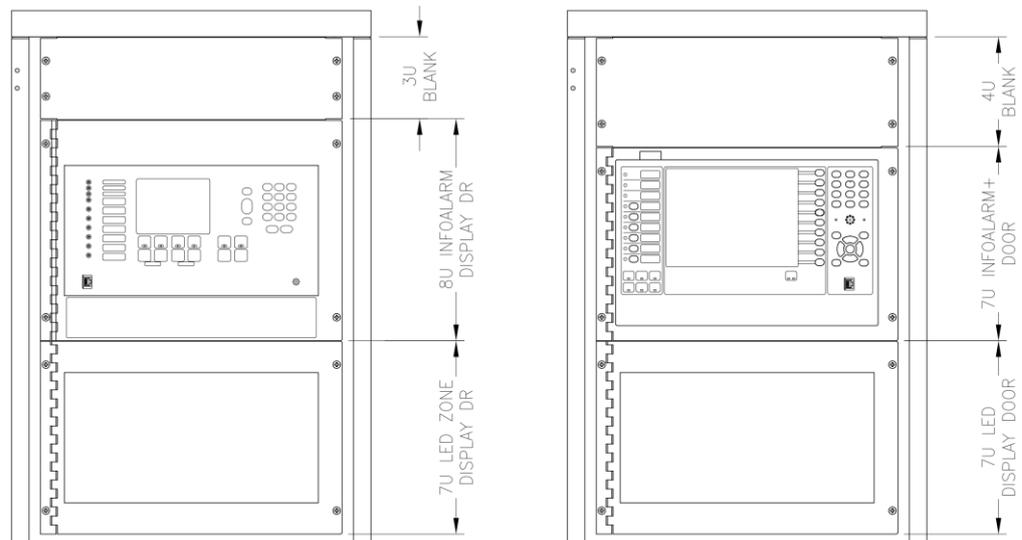
The 8U InfoAlarm door is replaced with a 7U InfoAlarm+ door.

The 3U blank panel at the top of the cabinet is replaced with a 4U blank panel to fill the gap.

Figure 1 – Face layout of the panel before (left), and after (right) the 4100ESi upgrade

- Unfasten and remove the 8U InfoAlarm door.
- Unfasten and remove the 3U blank panel at the top of the cabinet. Fit the 4U blank panel in its place. This will require the lower pair of the cage nuts to be moved down three holes.

- Fit the 7U InfoAlarm+ upgrade door in place and fasten it on its left side. This will require the upper pair of cage nuts to be moved down three holes.

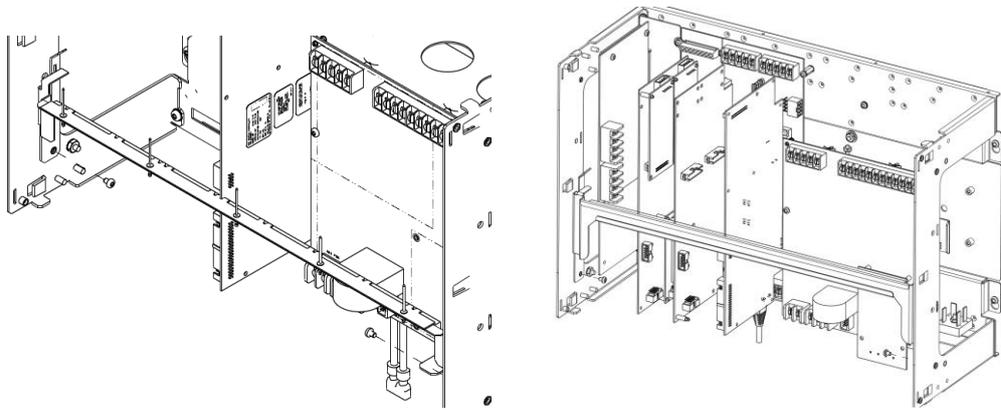
Figure 2 – Removing the old card restraint bar from the CPU bay (left), and replacing it with the new card restraint bar (right)

- For 4100U-S1: remove the old 4100U CPU card. Fit the upgrade (4100ES) CPU card in its place.
- Remove the card restraint bar in top bay. Replace with the card restraint bar supplied with the upgrade InfoAlarm+ door. See Figure 2.

- P3 should be in the ON position.
- Remove the old 4100U CPU card. Fit the upgrade 4100ES CPU card in its place.
- Remove the card restraint bar from the top bay. Replace with the card restraint bar supplied with the upgrade InfoAlarm+ door. Refer to Figure 2 for detail.

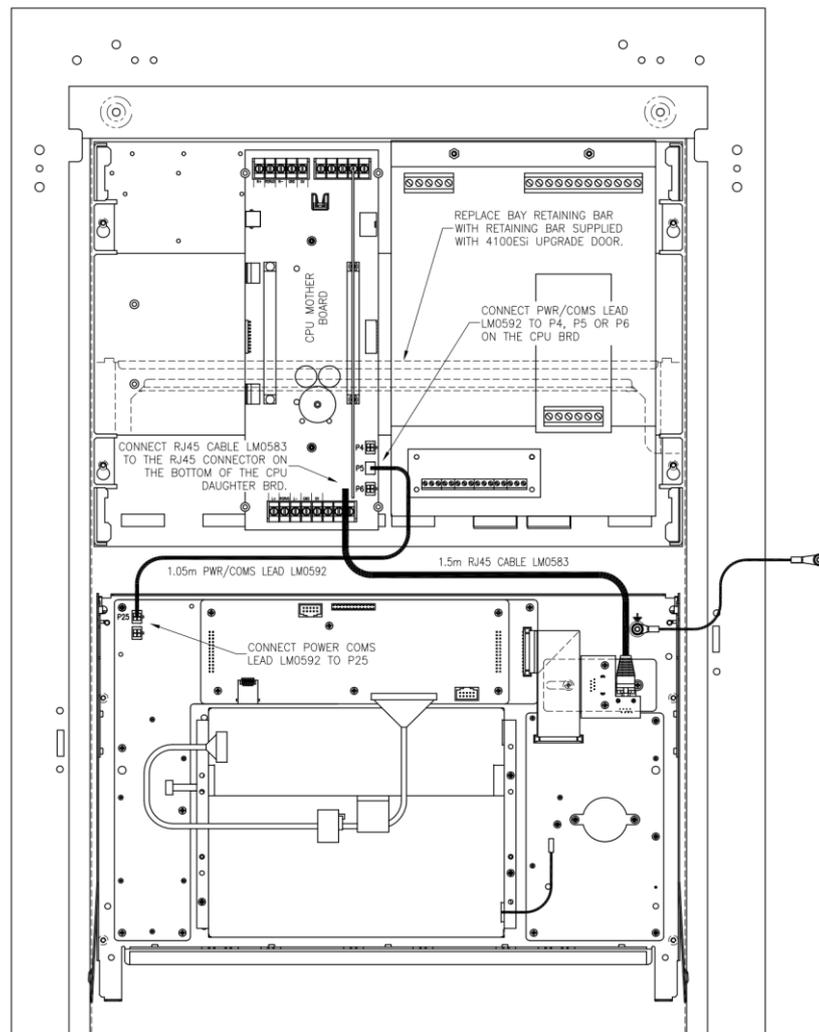
Figure 3 – Connecting the new InfoAlarm+ display door to the CPU bay

- Connect the InfoAlarm+ door to the bay, as shown in Figure 3:
  - Connect the earth lead at the right side of the InfoAlarm+ door to the bay side in place of the old earth lead.

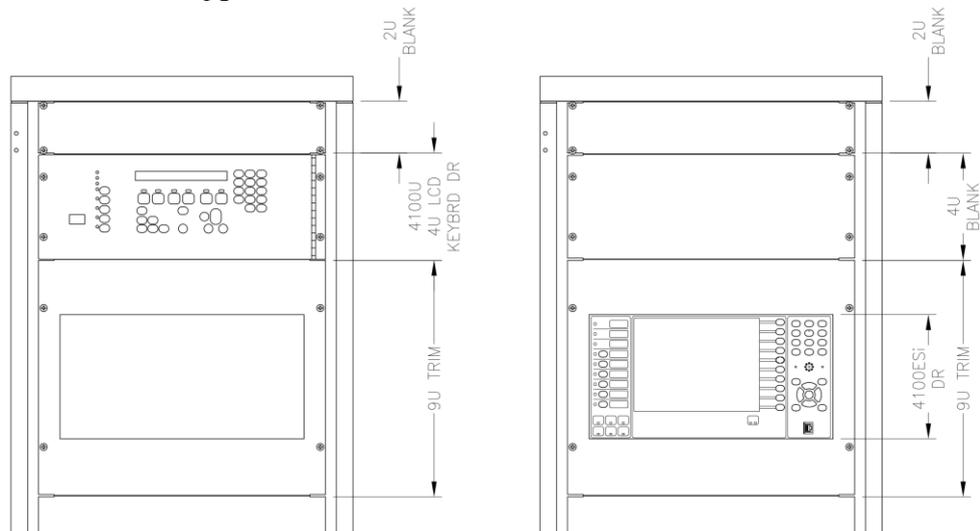
The LCD door is replaced with a blank panel.

The topmost zone indicator/control door is replaced with the InfoAlarm+ touchscreen.

The CPU board is upgraded to 4100ES.

Figure 4 – Face layout of the panel before (left), and after (right) the 4100ESi upgrade

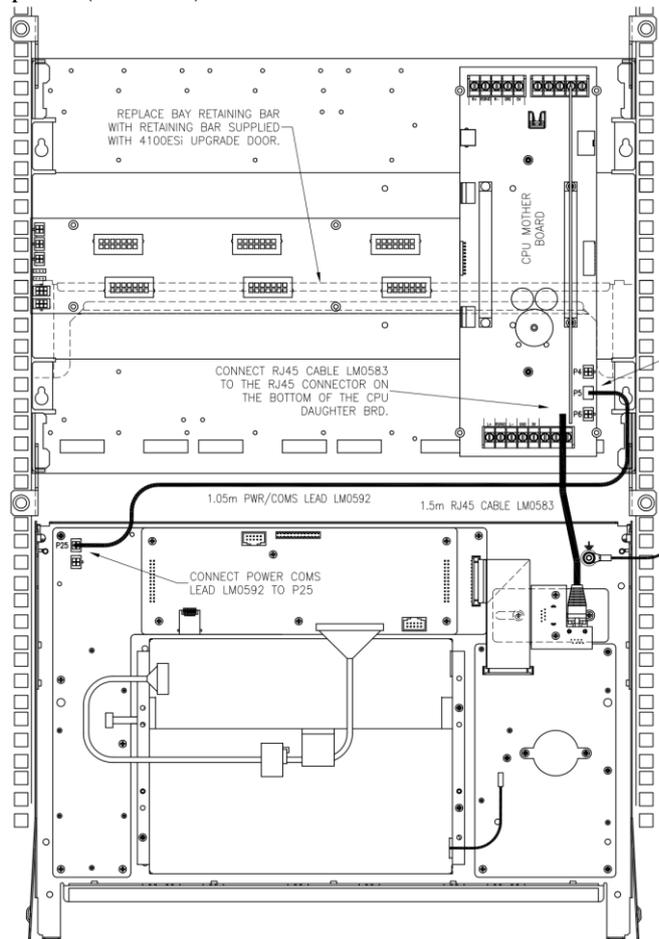
- Connect the InfoAlarm+ door to the bay, as shown in Figure 5:
  - Connect the earth lead at the right side of the InfoAlarm+ door to the bay side in place of the old earth lead.

- Connect the Ethernet lead from the InfoAlarm+ door to the Ethernet port on the bottom edge of the new CPU board.

- Connect the 4 way power/comms lead from the InfoAlarm+ door to an unused socket on the CPU motherboard (any of P4, P5 or P6) or on the PDI backplane (P2 or P3).

Figure 5 – Connecting the new InfoAlarm+ display door to the CPU bay
