MX4428 / F4000 / F3200 / NDU / RDU / ADU KEYPAD CONNECTOR FAULTS

IDENTIFICATION & FIELD CHANGEOVER PROCEDURE

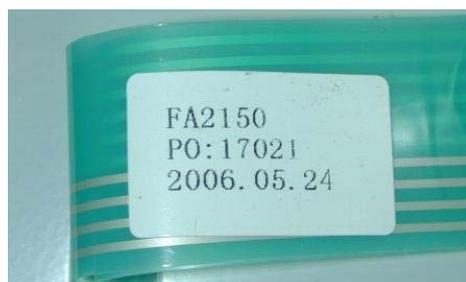
Fig 1 – Typical Batch Label (this one dated 24th May 2006)

To determine whether a particular panel contains an affected keypad it is necessary to open up the panel and look for the manufacturer's batch label on the keypad tail. This is a white stick-on label with the manufacturing date in the format YYYY-MM-DD printed on it (other information will also be present) as per Fig 1.

If the batch label date is in the range 1st March 2006 (2006. 03. 01) to 30th October 2006 (2006. 10. 30), then the keypad is potentially affected, however the actual failure incidence appears to be small and also appears to drop off rapidly with time (i.e. most failures are detected in factory test or during system commissioning).

Based on to-date failures and warranty return rates, keypad replacement whenever a fault is observed is the recommended action.
